**Flood Control Project Maintenance**  
**2015 Structure Summary Report**  
**Overall Unit and Item Ratings**

## Reclamation District No. 2096 Wetherbee Lake

### Wetherbee Lake Pumping Plant & Navigation Gate

**Flood Control Project Maintenance****Unit Cover Sheet****2015 Pumping Plant Inspection Results****Reclamation District No. 2096 Wetherbee Lake**

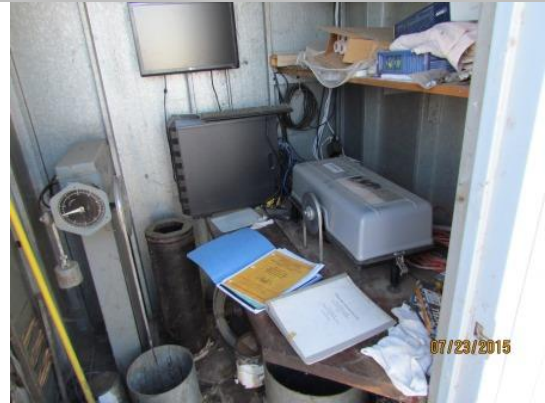
Photo 1 of 1 : ST\_2015\_RD2096\_56\_1\_20150814\_00013.jpg

LM Start	0.00	Rating **	A	Issue No.	1
LM End	0.00	Issue Type +	Ma	Location *	
Category	Pump Stations			GPS Latitude/Longitude	
				Start	End
Item	Operating Log			37.773864 °	37.773864 °
				-121.298427 °	-121.298427 °
DWR ID	DWR_RD2096_56_t_2012_1				
Action/Comments					
Inspector Comments: O&M log presented at time of inspection

View of the Operating Log and O&M Manual.

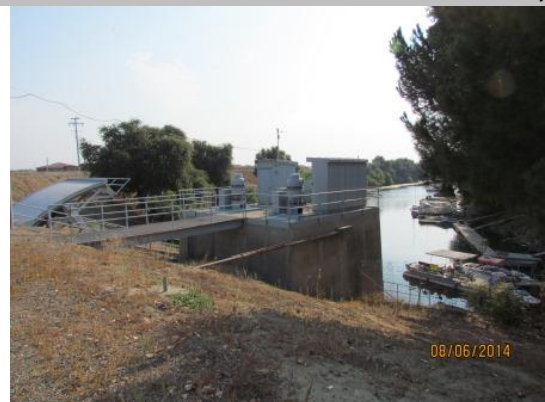
Photo 1 of 1 : ST\_2015\_RD2096\_56\_3\_20150709\_00002.jpg

LM Start	0.00	Rating **	A	Issue No.	3
LM End	0.00	Issue Type +	Ma	Location *	
Category	Pump Stations			GPS Latitude/Longitude	
				Start	End
Item	Plant Building			37.773864 °	37.773864 °
				-121.298430 °	-121.298430 °
DWR ID	DWR_RD2096_56_t_2012_3				
Action/Comments					
Inspector Comments: Building protects the controls only.

View of the pumping facility and navigation gate.

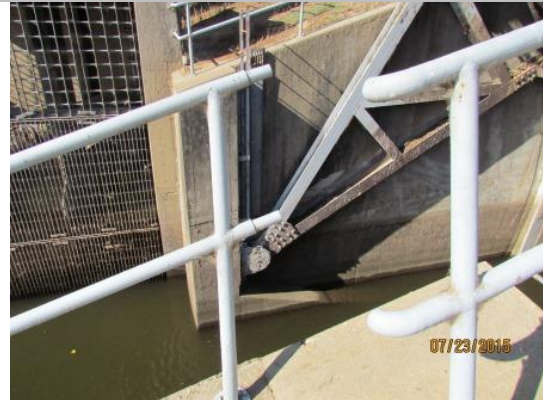
Photo 1 of 1 : ST\_2015\_RD2096\_56\_5\_20150814\_00014.jpg

LM Start	0.00	Rating **	M	Issue No.	5
LM End	0.00	Issue Type +	Ma	Location *	
Category	Pump Stations			GPS Latitude/Longitude	
				Start	End
Item	Safety			37.773864 °	37.773864 °
				-121.298430 °	-121.298430 °
DWR ID	DWR_RD2096_56_t_2012_5				
Action/Comments					
Inspector Comments: Missing guard rail on navigation canal. Missing fire extinguisher.

View of the missing guard rail.

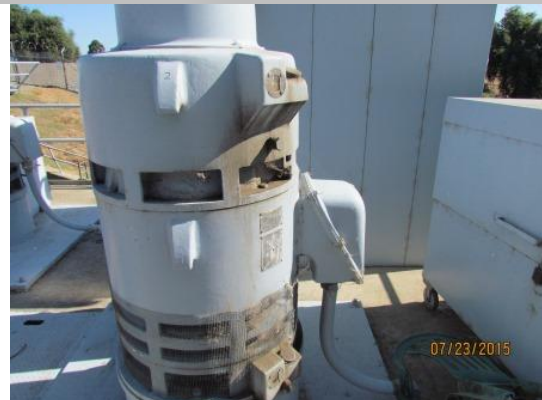
Photo 1 of 1 : ST\_2015\_RD2096\_56\_10\_20150814\_00015.jpg

LM Start	0.00	Rating **	A	Issue No.	10
LM End	0.00	Issue Type +	Ma	Location *	
Category	Pump Stations			GPS Latitude/Longitude	
				Start	End
Item	Motors, Engines, Fans & Gear Reducers			37.773864 °	37.773864 °
				-121.298430 °	-121.298430 °
DWR ID	DWR_RD2096_56_t_2012_10				
Action/Comments					
Inspector Comments: All items appear operational.

View of the pump motors.

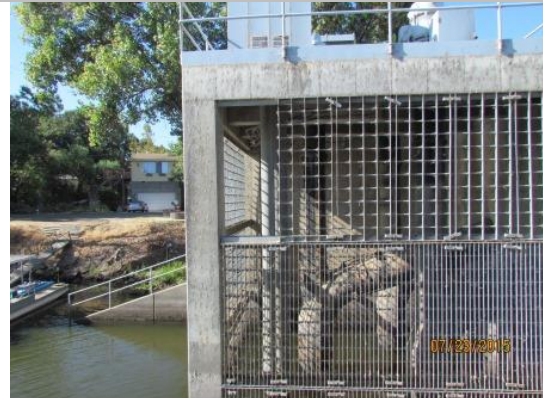
Photo 1 of 1 : ST\_2015\_RD2096\_56\_12\_20150814\_00016.jpg

LM Start	0.00	Rating **	A	Issue No.	12
LM End	0.00	Issue Type +	Ma	Location *	
Category	Pump Stations			GPS Latitude/Longitude	
				Start	End
Item	Sumps/Wet Well			37.773864 °	37.773864 °
				-121.298430 °	-121.298430 °
DWR ID	DWR_RD2096_56_t_2012_12				
Action/Comments					
Inspector Comments: Sump is clear of debris.

View of the pump intake system. Note the missing grate at top left corner.

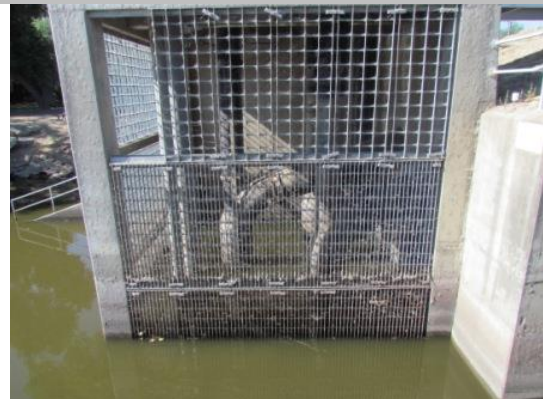
Photo 1 of 1 : ST\_2015\_RD2096\_56\_13\_20150709\_00006.jpg

LM Start	0.00	Rating **	M	Issue No.	13
LM End	0.00	Issue Type +	Ma	Location *	
Category	Pump Stations			GPS Latitude/Longitude	
				Start	End
Item	Trash Racks			37.773864 °	37.773864 °
				-121.298430 °	-121.298430 °
DWR ID	DWR_RD2096_56_t_2012_13				
Action/Comments					
Inspector Comments: Trash rack is present, however one panel is missing from rack.

Section of trash rack is missing, missing section would be in upper left of photo.

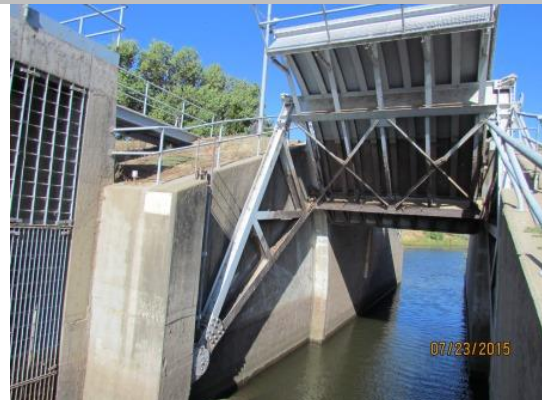
Photo 1 of 2 : ST\_2015\_RD2096\_56\_16\_20150814\_00017.jpg

LM Start	0.00	Rating **	A	Issue No.	16
LM End	0.00	Issue Type +	Ma	Location *	
Category	Pump Stations			GPS Latitude/Longitude	
				Start	End
Item	Electric Gate Operators			37.773864 °	37.773864 °
				-121.298430 °	-121.298430 °
DWR ID	DWR_RD2096_56_t_2012_16				
Action/Comments					
Inspector Comments: Item appears to be in good working condition. Radial arm gate was open at time of inspection.

View of the radial arm gate in the open position.

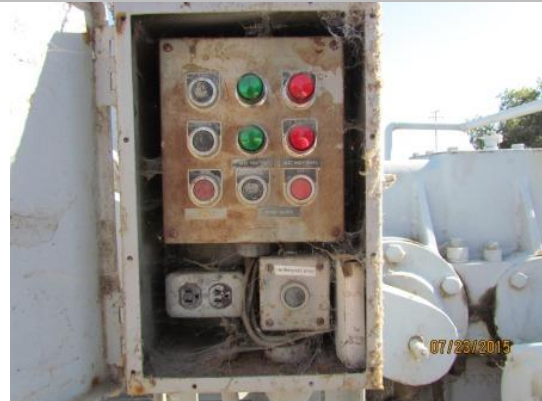
Photo 2 of 2 : ST\_2015\_RD2096\_56\_16\_20150814\_00018.jpg

LM Start	0.00	Rating **	A	Issue No.	16 (cont)	
LM End	0.00	Issue Type +	Ma	Location *		
Category	Pump Stations			GPS Latitude/Longitude		
				Start	End	
Item	Electric Gate Operators			37.773864 °	37.773864 °	
				-121.298430 °	-121.298430 °	
DWR ID	DWR_RD2096_56_t_2012_16					
Action/Comments						
Inspector Comments: Item appears to be in good working condition. Radial arm gate was open at time of inspection.

View of the gate controls.

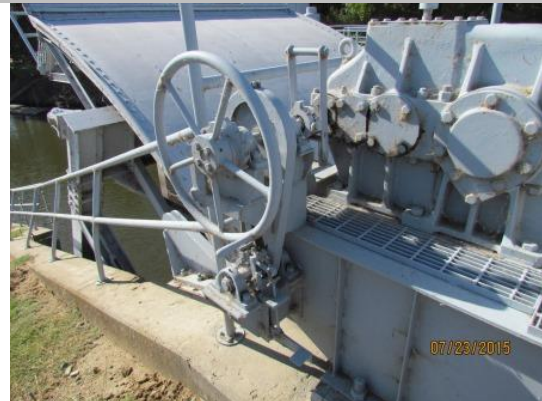
Photo 1 of 1 : ST\_2015\_RD2096\_56\_17\_20150814\_00019.jpg

LM Start	0.00	Rating **	U	Issue No.	17
LM End	0.00	Issue Type +	Ma	Location *	
Category	Pump Stations			GPS Latitude/Longitude	
				Start	End
Item	Manual Gate Operators			37.773864 °	37.773864 °
				-121.298430 °	-121.298430 °
DWR ID	DWR_RD2096_56_t_2012_17				
Action/Comments					
Inspector Comments: Manual gate operators could not be engaged to test the functionality of the system.

View of the manual gate operation control.

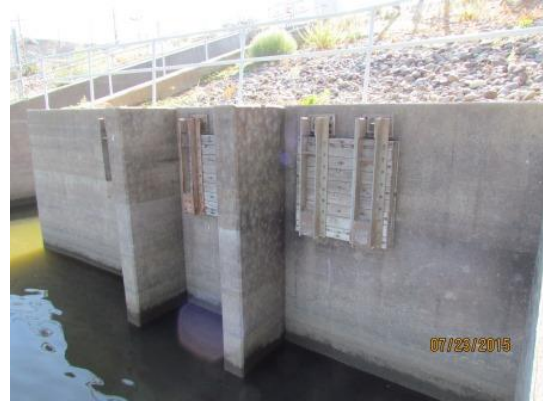
Photo 1 of 1 : ST\_2015\_RD2096\_56\_19\_20150814\_00020.jpg

LM Start	0.00	Rating **	A	Issue No.	19
LM End	0.00	Issue Type +	Ma	Location *	
Category	Pump Stations	GPS Latitude/Longitude			
		Start	End		
Item	Flap Gates	37.773864 °		37.773864 °	
		-121.298430 °		-121.298430 °	
DWR ID	DWR_RD2096_56_t_2012_19				
Action/Comments					
Inspector Comments: Flap gates appear to be fully operational.

View of the flapgates.

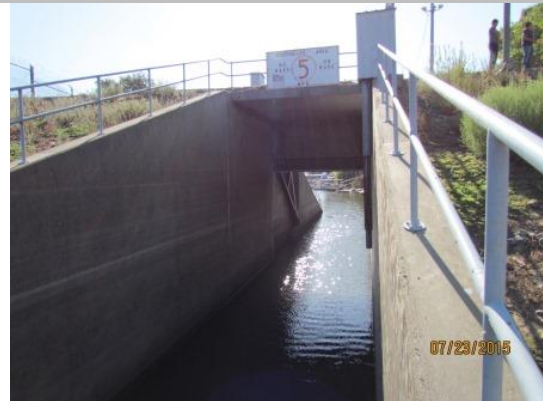
Photo 1 of 1 : ST\_2015\_RD2096\_56\_20\_20150814\_00021.jpg

LM Start	0.00	Rating **	A	Issue No.	20
LM End	0.00	Issue Type +	Ma	Location *	
Category	Pump Stations			GPS Latitude/Longitude	
				Start	End
Item	Closure Structures			37.773864 °	37.773864 °
				-121.298430 °	-121.298430 °
DWR ID	DWR_RD2096_56_t_2012_20				
Action/Comments					
Inspector Comments: Radial arm gate acts as closure structure, gate was open at time of inspection.

Radial arm gate, shown in open position.

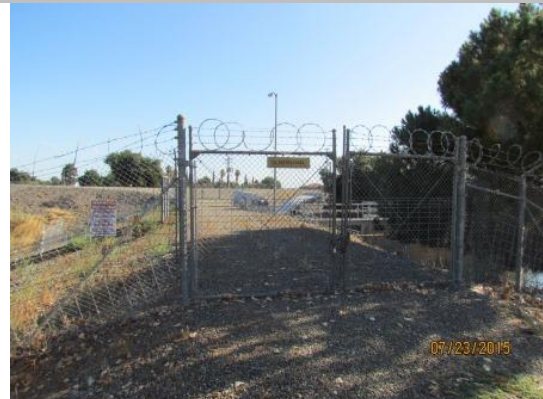
Photo 1 of 1 : ST\_2015\_RD2096\_56\_21\_20150814\_00022.jpg

LM Start	0.00	Rating **	A	Issue No.	21
LM End	0.00	Issue Type +	Ma	Location *	
Category	Pump Stations			GPS Latitude/Longitude	
				Start	End
Item	Security Fencing			37.773864 °	37.773864 °
				-121.298430 °	-121.298430 °
DWR ID	DWR_RD2096_56_t_2012_21				
Action/Comments					
Inspector Comments: Security fencing is in place. Closed circuit cameras are also in place.

View of the security fencing around the facility.

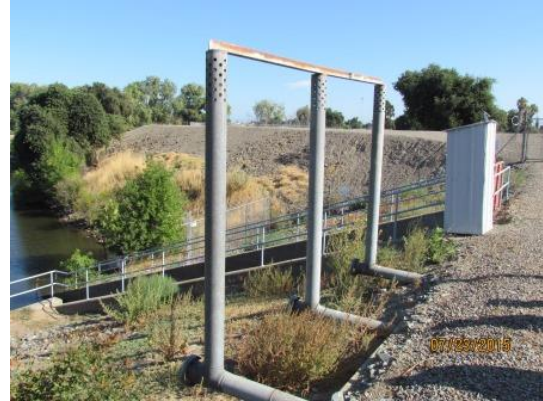
Photo 1 of 1 : ST\_2015\_RD2096\_56\_22\_20150814\_00023.jpg

LM Start	0.00	Rating **	A	Issue No.	22
LM End	0.00	Issue Type +	Ma	Location *	
Category	Pump Stations			GPS Latitude/Longitude	
				Start	End
Item	Intake and Discharge Pipes			37.773864 °	37.773864 °
				-121.298430 °	-121.298430 °
DWR ID	DWR_RD2096_56_t_ 2012_22				
Action/Comments					
Inspector Comments: Pipes appear to be free of defects.

View of the siphon breakers at the levee crown.
